O. V. Balan, S. H. Brylka, S. S. Pidbereznyi, V. M. Rudko

*Institute for Safety Problems of Nuclear Power Plants, NAS of Ukraine, 36a, Kirova st., Chornobyl, 07270, Ukraine*

## Peculiarities of the Shelter Object Individual Unstable Structures Dismantling

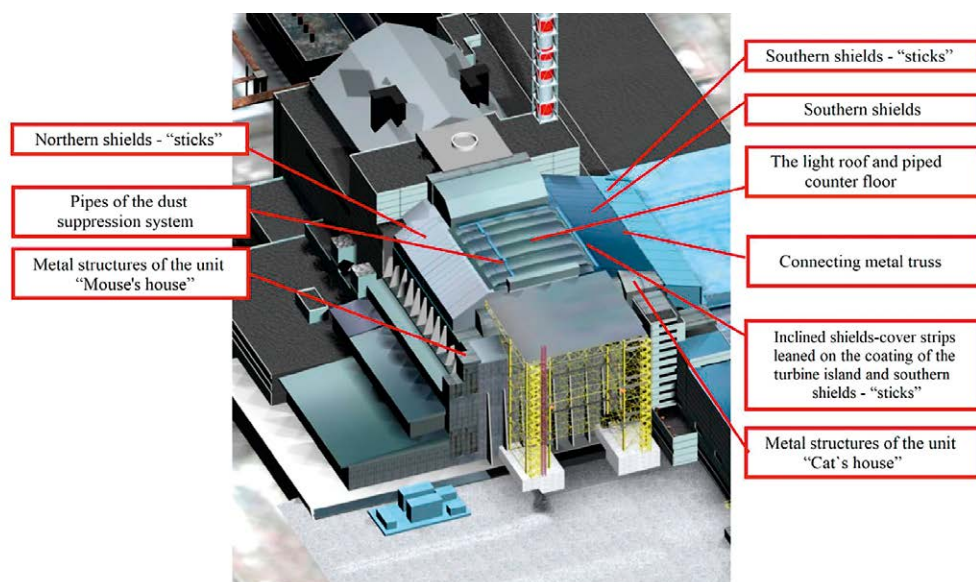
Fig. 1. Structures subject to “early” dismantling

The unstable structures subject to “early” dismantling include metal structures forming the external outline shell of the Shelter Object (Fig. 1), as well as piped roof sheathing, the Octopus Beam, the Mammoth Beam, the Mammoth Beam supporting structures, blockages on the deaerator stack and emergency slabs of its surface. The rest of the unstable structures, such as beams B1 and B2, blockages and ceiling slabs above room 805/3, the Dog House three-dimensional unit and other structures, are classified for “delayed” dismantling (Fig. 2).

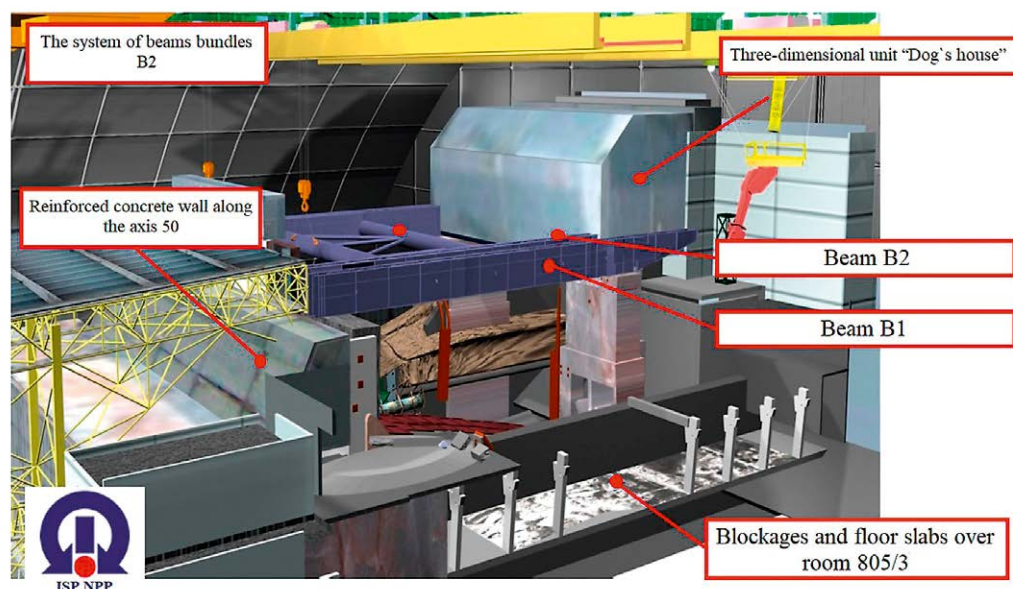
Fig. 2. Structures subject to “delayed” dismantling

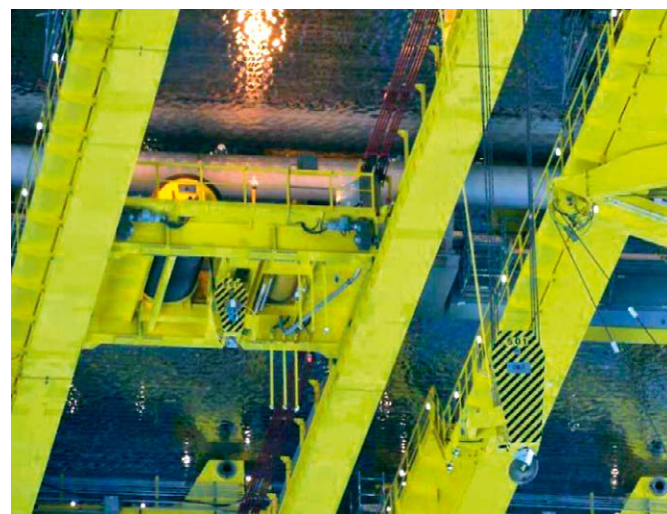
Fig. 3. MCS general view

The crane bridges move along the tracks on the under-crane rails and have a suspended structure. Since the bridge has considerable length (96 meters), each of the bridges moves on six under-crane rails. The length of each under-crane rail is 150 meters. The crane bridges

move in an east-west direction, while the trolleys move in a north-south direction (Fig. 3).

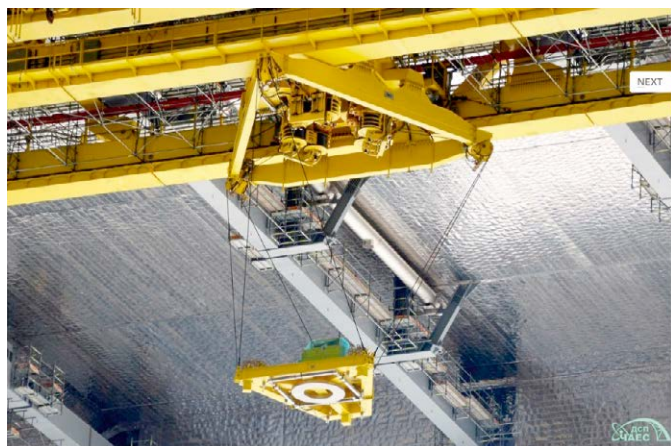
Fig. 4. Load trolley fitted with MIP

A load trolley fitted with MIP is equipped with a special rigging system. The MIP consists of an upper and lower platform (Fig. 4). The lower platform of the MIP is equipped with a device for attaching a manipulator (mechanical arm) capable of performing technological operations using changeable tools and attachments.

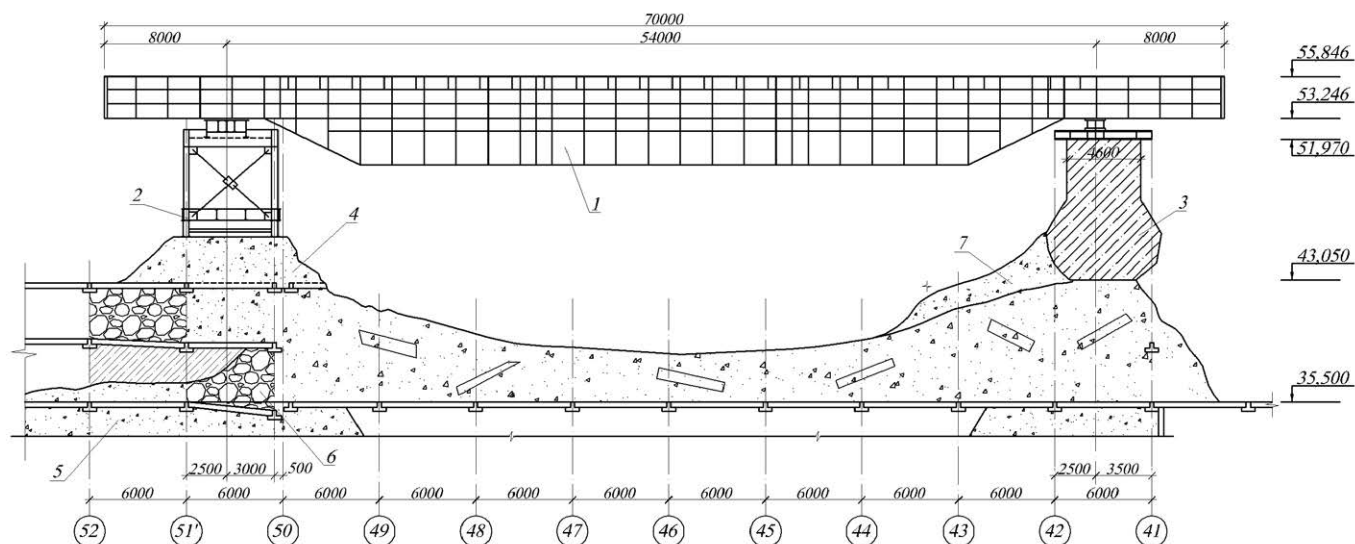
Fig. 5. The layout of the Mammoth Beam: 1 — the Mammoth Beam; 2 — western supporting structure; 3 — eastern supporting structure; 4 — building materials debris, reinforced with concrete at the supporting structures; 5 — concreted premises of the deaerator stack; 6 — concrete bags; 7 — supporting structure concrete reinforced rock installation

The Mammoth Beam is located between axes 40–51. The total length of the Mammoth Beam is 70 meters, with a distance between the centers of supporting structures measuring 54 meters. The beam's weight is 127 tons. The beam is supported by a metal western supporting structure located between axes 50–51 and an eastern concrete supporting structure located between axes 41–42. The diagram of the Mammoth Beam is shown in Fig. 5.

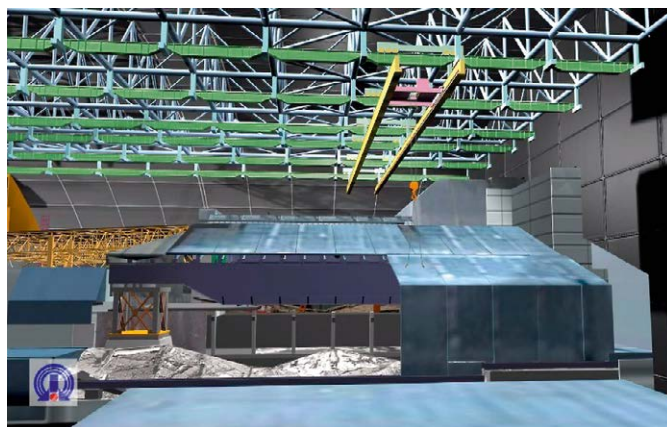
Fig. 6. Stick shields dismantling

It should be noted that the two branches of the Mammoth Beam serve as a supporting platform for almost all the roof shields of the Shelter Object southern roof area, which need to be dismantled before starting works on the beam. Therefore, the southern stick shields, light roof three-dimensional units, southern shields and the Cat House three-dimensional unit will be dismantled beforehand. The light roof three-dimensional units do not rely on the Mammoth Beam but also need to be dismantled, as they overlap the upper part of the southern shields. All the mentioned elements of the Shelter Object southern roof area will be dismantled using the NSC main cranes system. Computer models of such dismantling are shown in Figs 6–9.

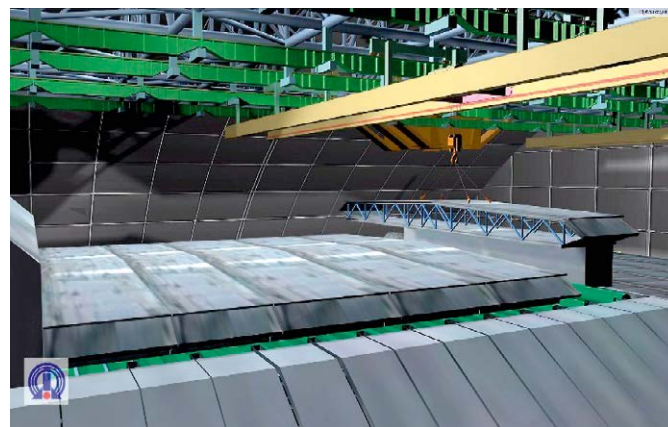
Fig. 7. Light roof three-dimensional units dismantling

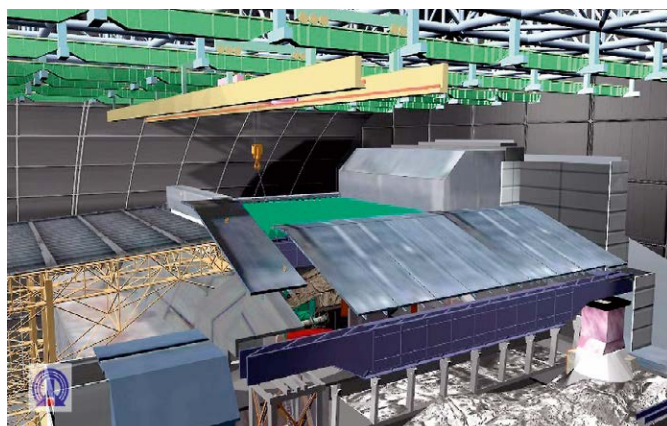
Fig. 8. Southern shields dismantling

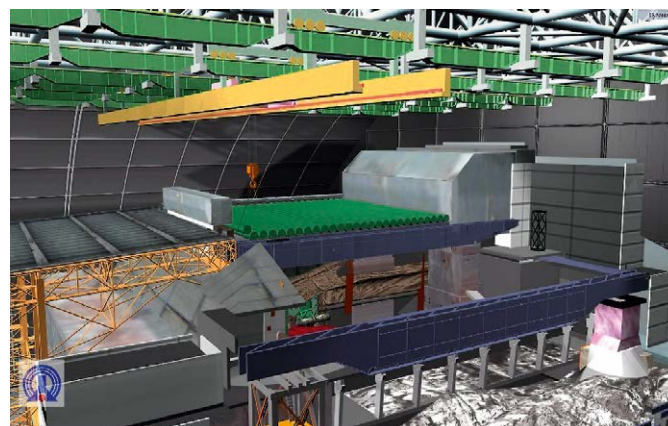
Fig. 9. The Cat House unit dismantling

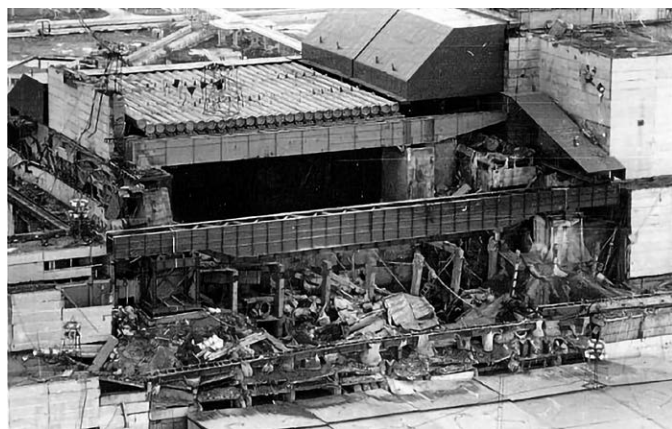
Fig. 10. Debris at the place of the Mammoth beam temporary support installation

The primary challenge in dismantling the Mammoth Beam is the inability to move it as a whole structure using the NSC cranes. Therefore, it is necessary to cut the beam into two parts. To carry out the cutting operation, a special temporary support must be installed under the Mammoth Beam near its midpoint. After cutting the Mammoth Beam, the length of its western part will be 38.5 meters with a weight of 71 tons, and the length of the eastern part will be 31.5 meters with a weight of 56 tons. It's worth noting that the space between the supports of the Mammoth Beam and between axes B-C-D is filled with debris from damaged construction structures (Figs 10 and 11). The height of the debris accumulation, in some places, reaches up to 4 meters. Therefore, the installation of the temporary support must be preceded by debris removal.

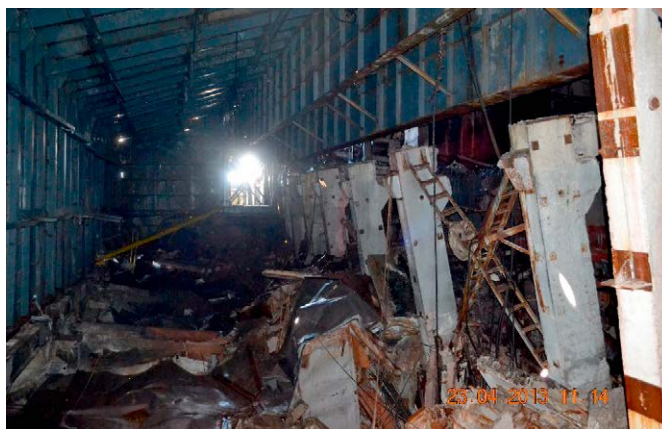
Fig. 11. Current state of the debris at the place of the Mammoth beam temporary support installation

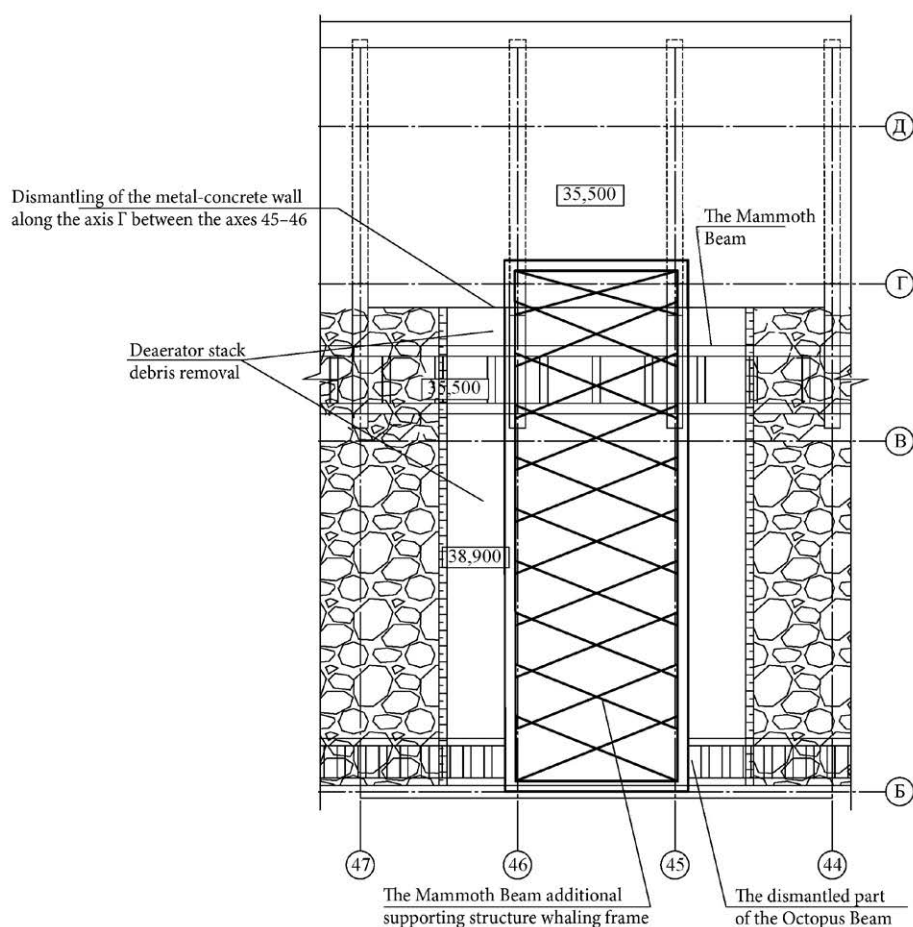
Fig. 12. Layout of the lower stationary part of the Mammoth Beam temporary support

part of the Mammoth Beam temporary support is shown in Fig. 12.

The proposed structure of the temporary support for the Mammoth Beam should consist of several main elements:

- the lower, stationary part, installed at mark of 38.600, will rest on the prepared areas of the walls along axes B, C, and D. This part of the support is a rigid framework structure made of rolled metal, which includes rails or slide guides at the center of the supporting structures.

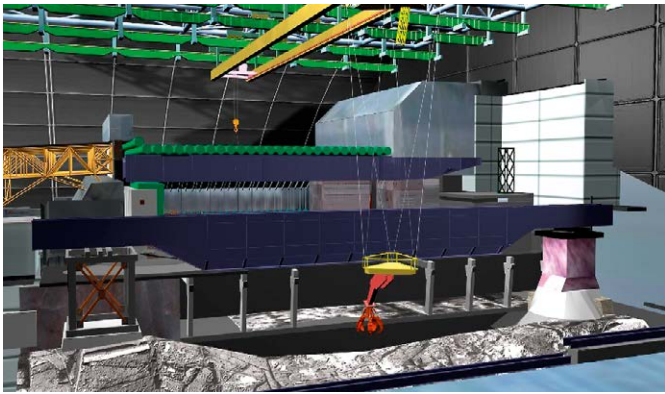
Fig. 13. The eastern NSC crane with MIP and a manipulator equipped with a special gripper disassembles fragments of building structures

further handling. Along with clearing debris, the cutting and dismantling of emergency reinforced concrete columns is carried out along axes 45 and 46 (Fig. 13);

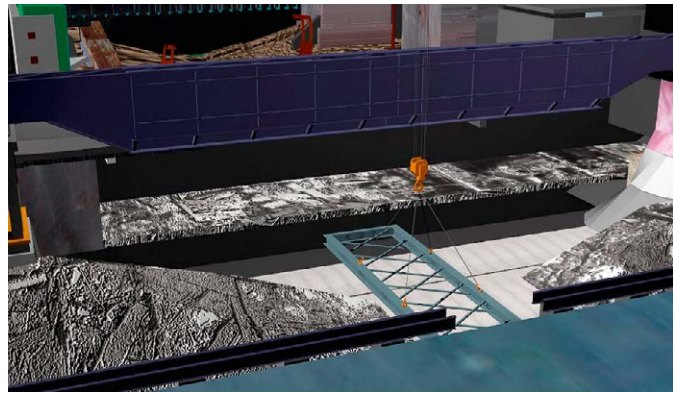
Fig. 14. Using the NSC crane, the lower stationary part of the Mammoth Beam temporary support is set in its design position on prepared wall supports

Mammoth Beam temporary support is transported to the WA and set in its design position rested on prepared wall supports along axes B, C, and D (Fig. 14);

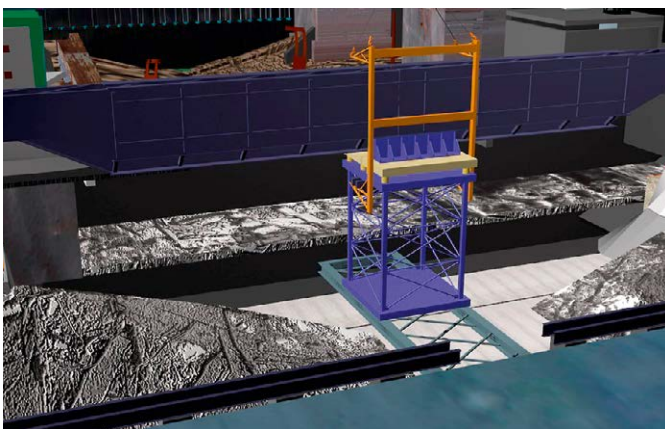
Fig. 15. Using the NSC crane, the middle movable part of the temporary support is installed on the lower stationary part

the NSC crane delivers the middle movable part of the temporary support to the WA and installs it on the lower stationary part (Fig. 15);

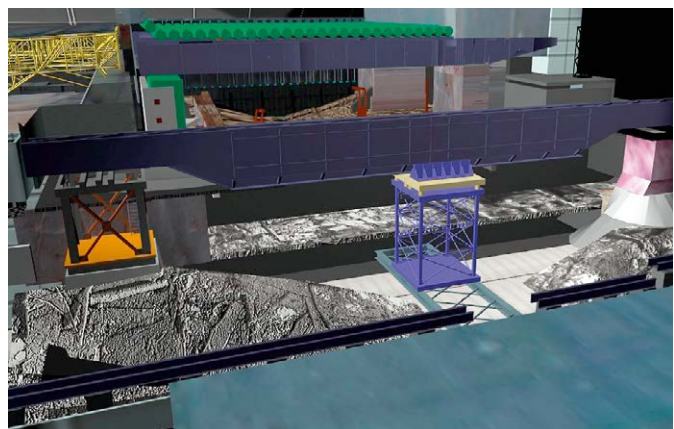
Fig. 16. The middle movable part of the temporary support is moved along the stationary part and set in the design position under the beam

due to the action of the jacks, the upper part of the support (platform) with independent cradles supports and reliably fixes the branches of the Mammoth Beam, the branches will keep fixed by the platform arresting devices within the entire period of work (Fig. 16);

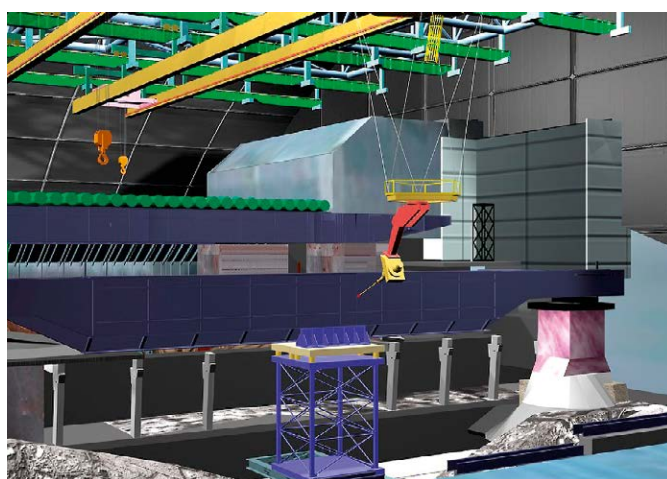
Fig. 17. Using the NSC crane with MIP and a manipulator equipped with a special air-plasma device transverse cutting of the Mammoth Beam branches is performed

the NSC crane with MIP and a manipulator equipped with a special air-plasma device are used for transverse cutting of the northern and southern branches of the Mammoth

Beam. The entire process is monitored by video surveillance equipment, and it also performs the final control of the cutting point to confirm the detachment of the parts (Fig. 17);

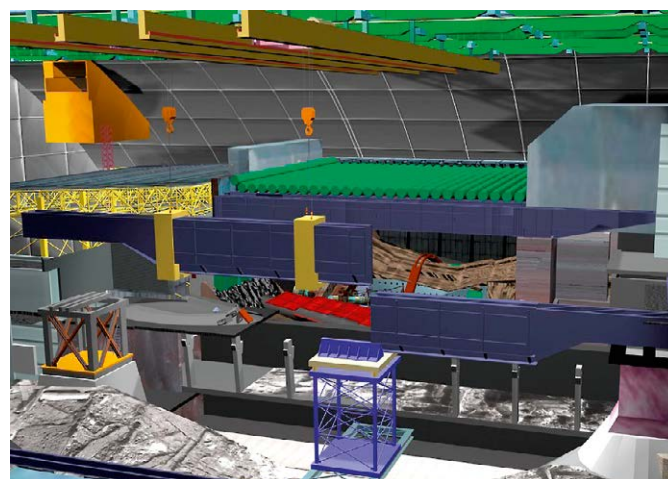
Fig. 18. Two NSC cranes equipped with special grips collaborate to fix the cut part of the Mammoth Beam, and transport it for further handling

two NSC cranes equipped with special grips collaborate to approach the Mammoth Beam, fix the western cut part, and, after verifying the reliability of the retention, remove it out of the WA for further handling. The eastern part of the beam is dismantled in the same way (Fig. 18).

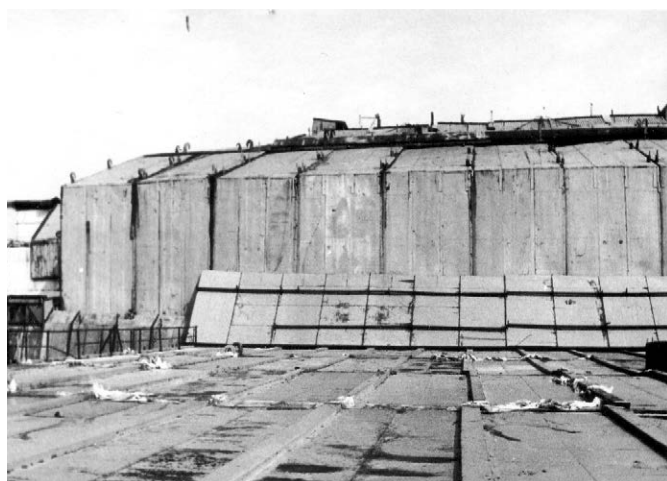
Fig. 19. General view of the shields-sealers after the Shelter Object final completion

Figs 19 and 20, show the location of these inclined shields-sealers on the Shelter Object roof immediately after its erection in 1986 and their state before the NSC installation in design position.

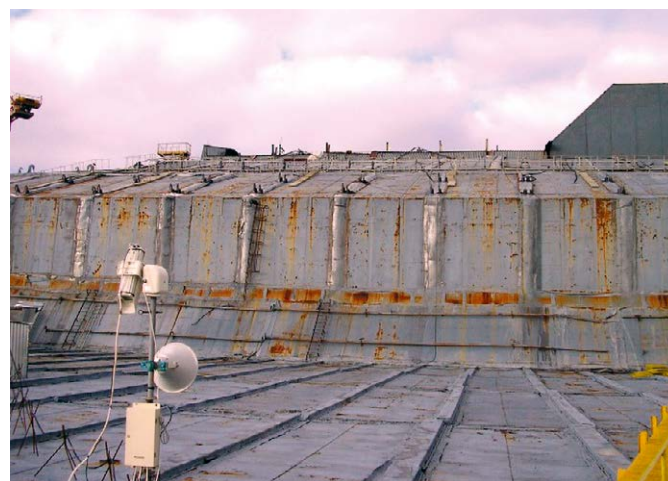
Fig. 20. State of the shields-sealers after the Shelter Object rooftop sealing completion

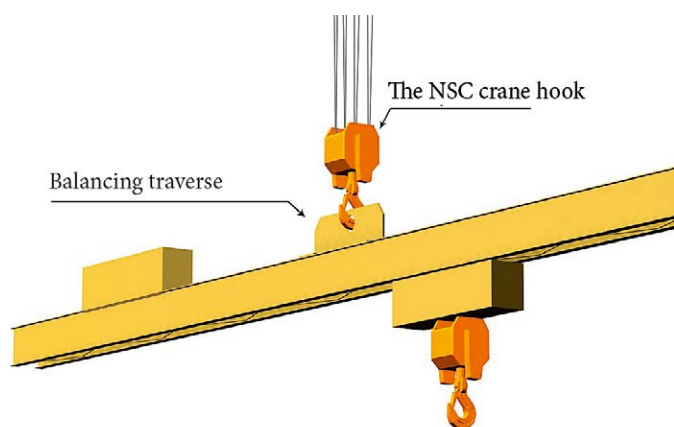
Fig. 21. Model of a balancing traverse for dismantling works

Since the inclined shields-sealers are located outside the operating zone of the NSC cranes, additional equipment should be used for their dismantling. A balancing traverse attached to the NSC crane hook expanding its lifting range could serve this purpose.

As an option, the balancing traverse may be designed as an extended frame with a suspension device and a hook

on one side and a movable counterweight on the other. During the dismantling process, a unit of shields-sealers may be hooked on the traverse hook using special gripping devices or slings. The counterweight is therefore shifted from the neutral position (centered on the frame) to the opposite side of the load using an electric drive until the weight is balanced.

Figs 21 and 22 demonstrate a possible model of the balancing traverse and a computer model of the shields-sealers units dismantling process.

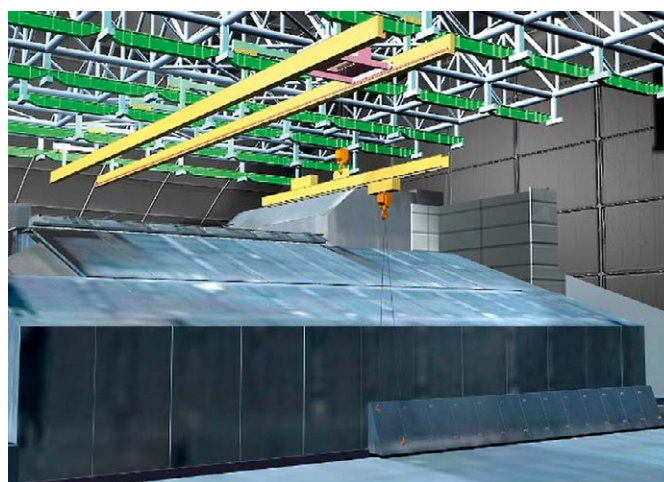
Fig. 22. Shields-sealers units dismantling using the NSC crane with a balancing traverse
